Mountain Valley Home Inspections

1010 Carpenter Lane
Montrose, Co 81401

Page 2 of 18
Townsley(tmp).inspx

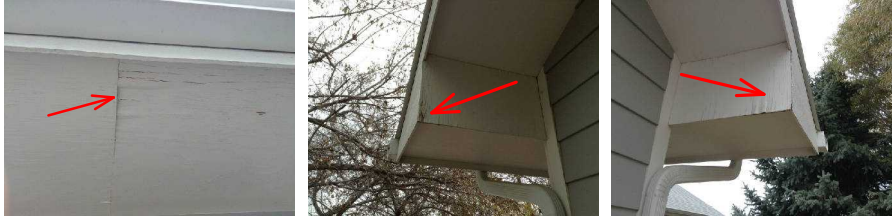
- 1. Type: Brick veneer, Fibrous
- 2. Trim: Wood
- 3. Fascia: Composite material
- 4. Soffits: Plywood Wood rot needs paint

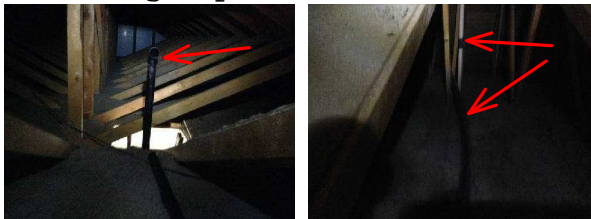
- 1. Service Line: Copper, PVC
- 2. Main Water Shutoff: At meter
- 3. Water Lines: PVC
- 4. Drain Pipes: PVC
- 5. Service Caps: Not visible
- 6. Vent Pipes: ABS, PVC. Venting of garage sink broke , A licensed plumber is recommended to evaluate and estimate repairs. This can cause methane gas problems.

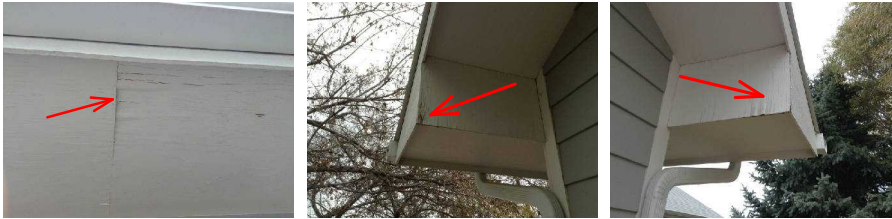
2. Soffits: Plywood Wood rot needs paint

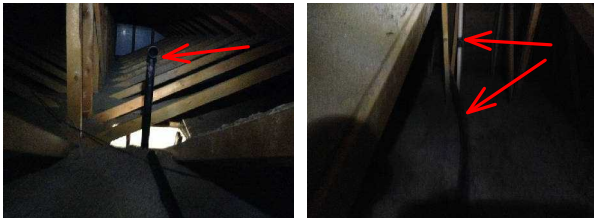
7. Vent Pipes: ABS, PVC. Venting of garage sink broke , A licensed plumber is recommended to evaluate and estimate repairs. This can cause methane gas problems.
